Frontera Force Main Update

Frontera Force Mains: Essential Wastewater Artery

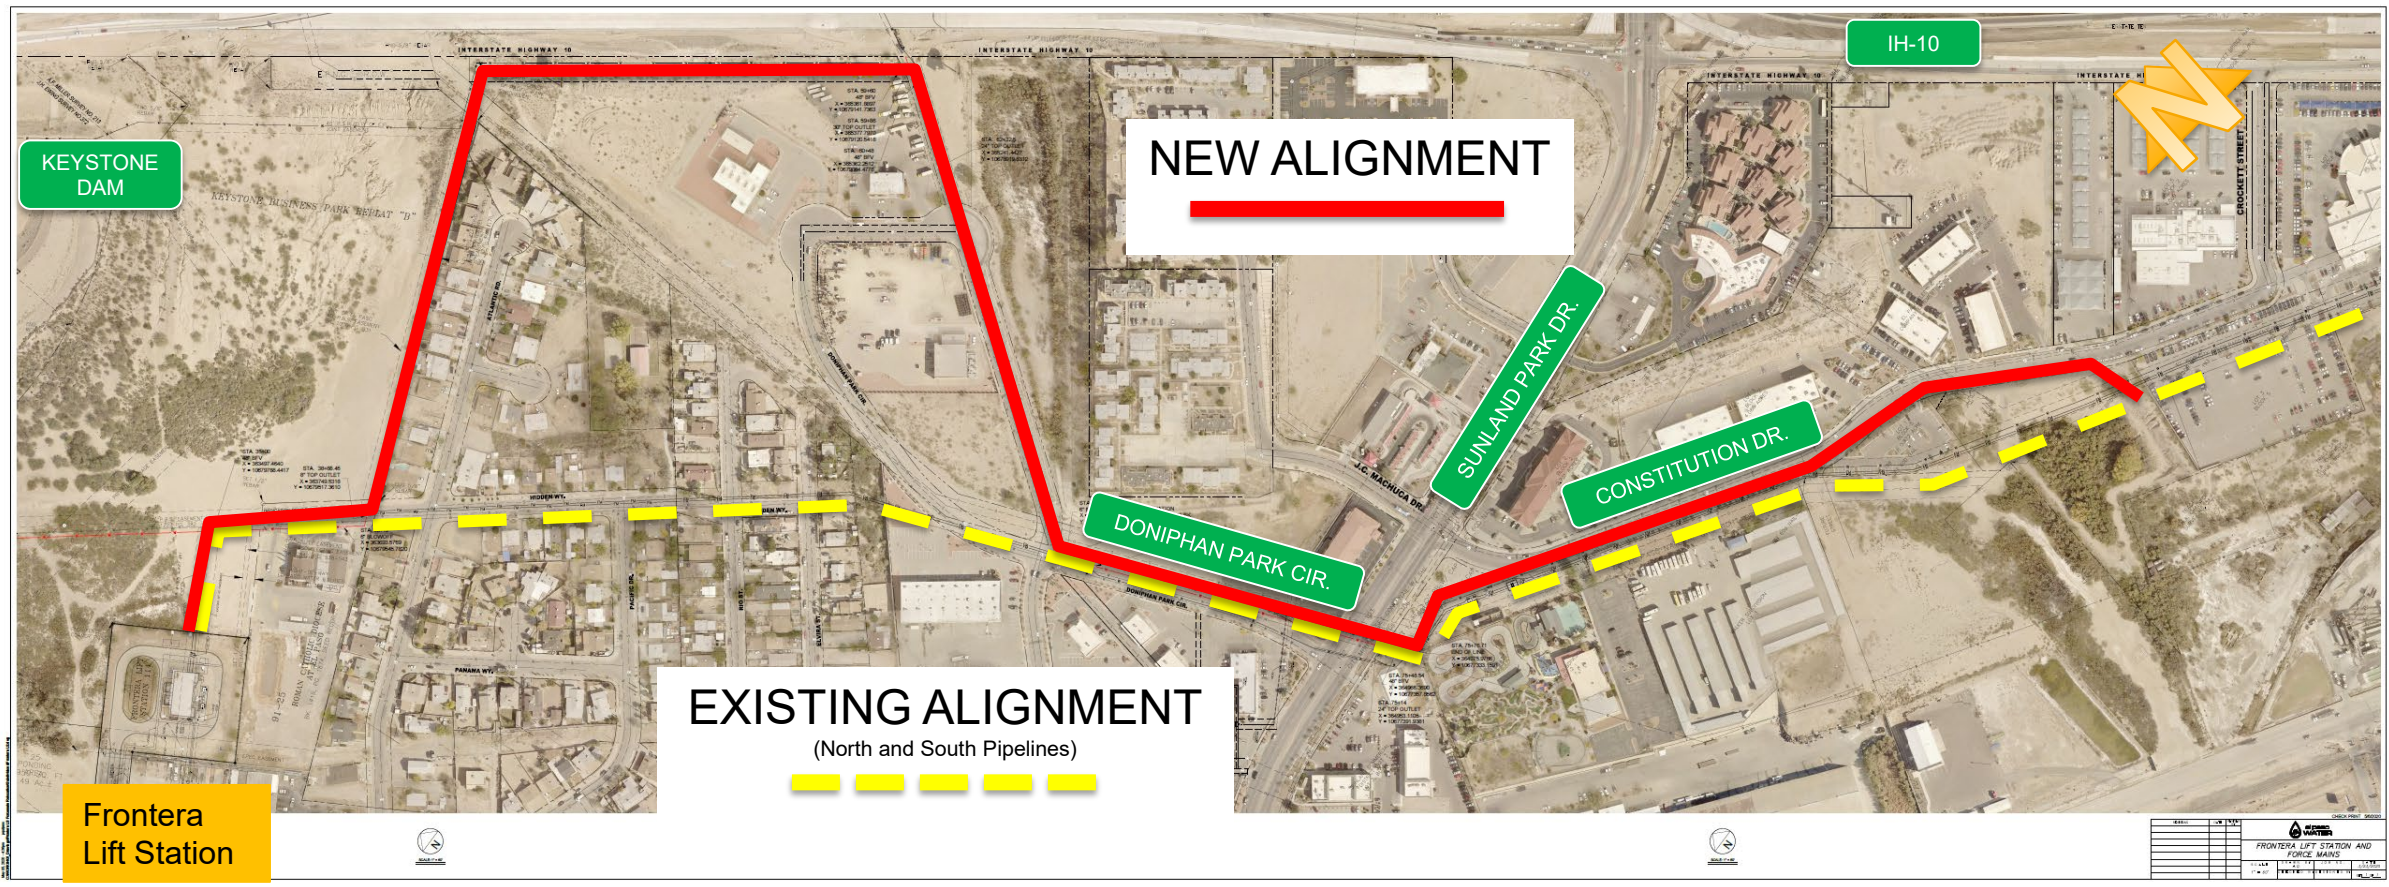
Emergency Repairs to Frontera Force Mains

Replace 1.2 miles of 36" Force Main
