# Quarterly Presentation: Final Report on Northeast Main Break Incident

June 23, 2026

# Northeast Main Break Incident Overview

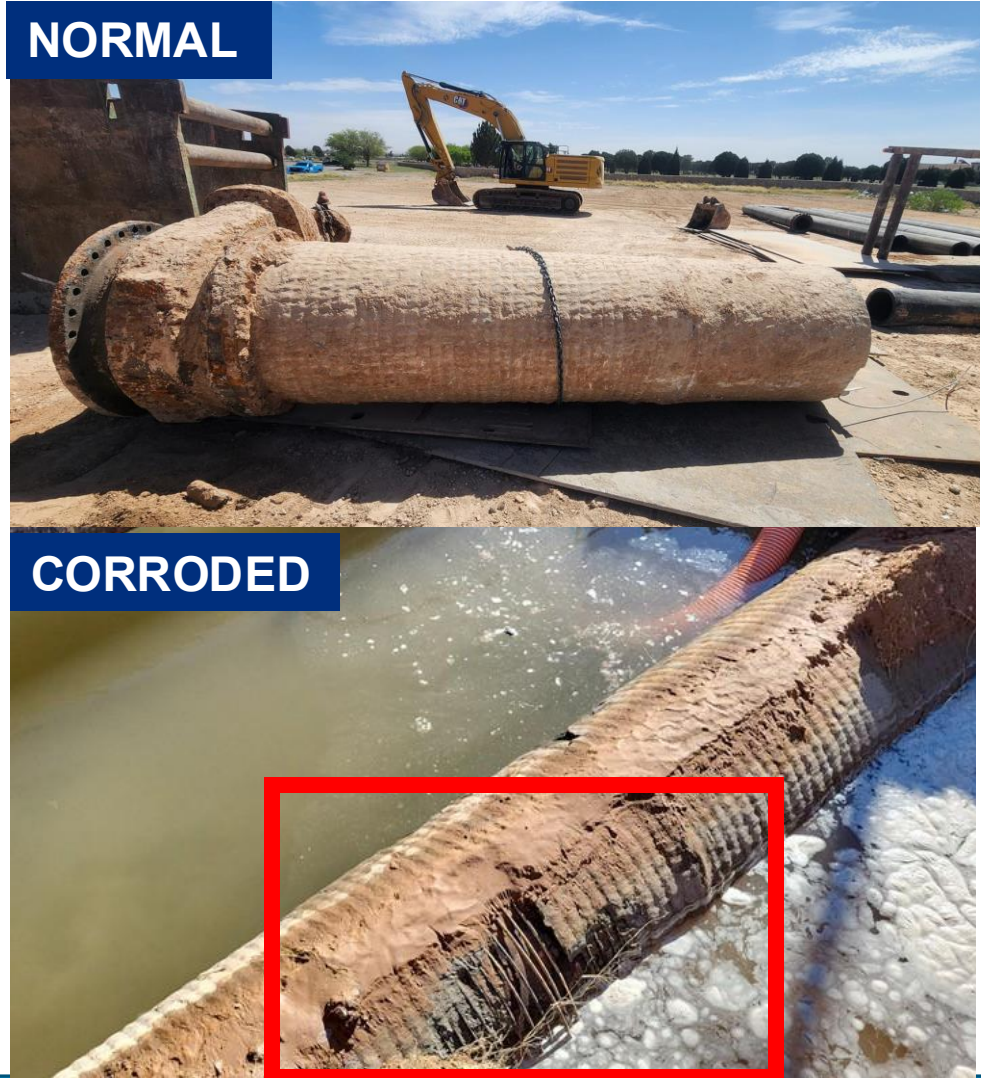
The 36-inch transmission main was constructed of pre-stressed steel cylinder concrete pipe

- Broken segment removed and sent in for forensic analysis

The break was determined to be caused by corrosion and an electrical surge-induced pressure spike in the system.

- The pressure spike caused the corroded segment of pipe to break

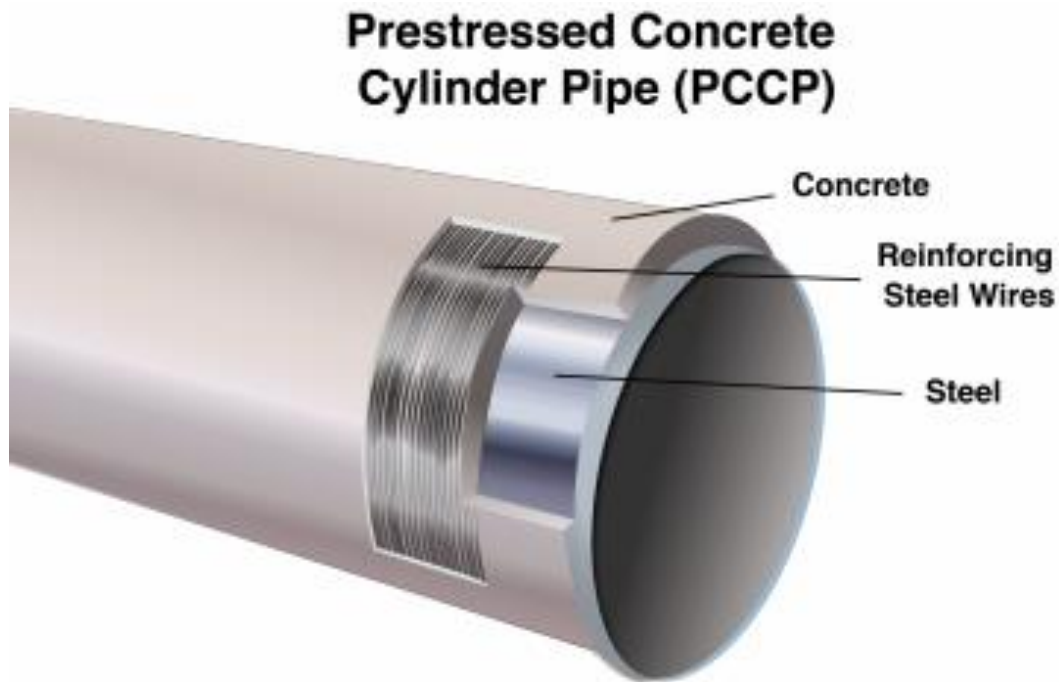
# Pre-stressed Concrete Cylinder Pipe

This type of pipe was common when installed

- Design is outdated and no longer used in today's pipeline construction
- Newer technologies and materials now produce more durable pipe segments
- This type of pipe design has led to major breaks in other cities

Recent assessment of other sections of PCCP are cause for concern

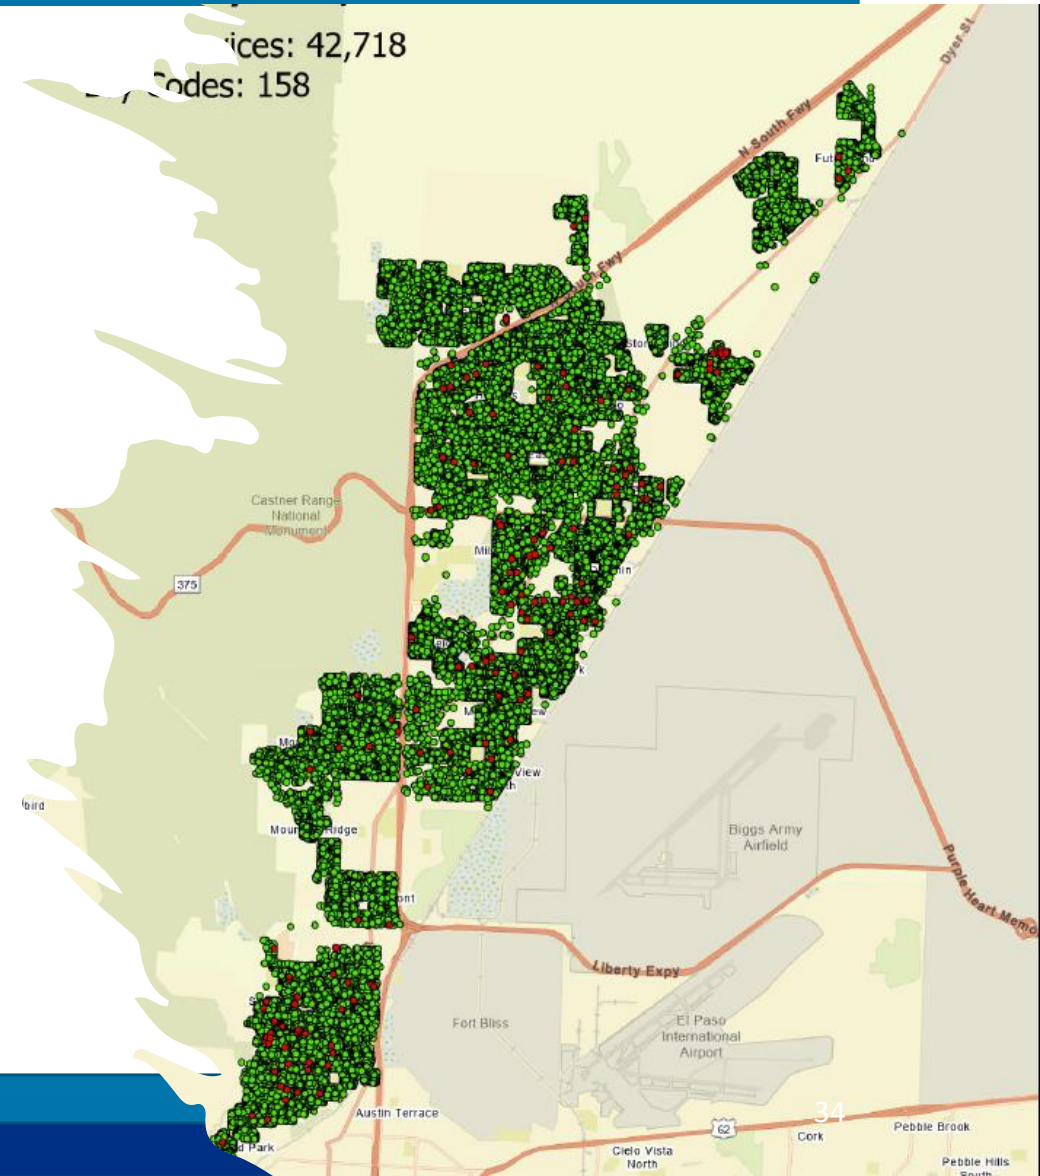
# Service Map for Saturday January 10<sup>th</sup>

- Looking for conglomeration of datapoints giving the same state
  - Green dots - customers with service
  - Red dots - meters reporting dry code

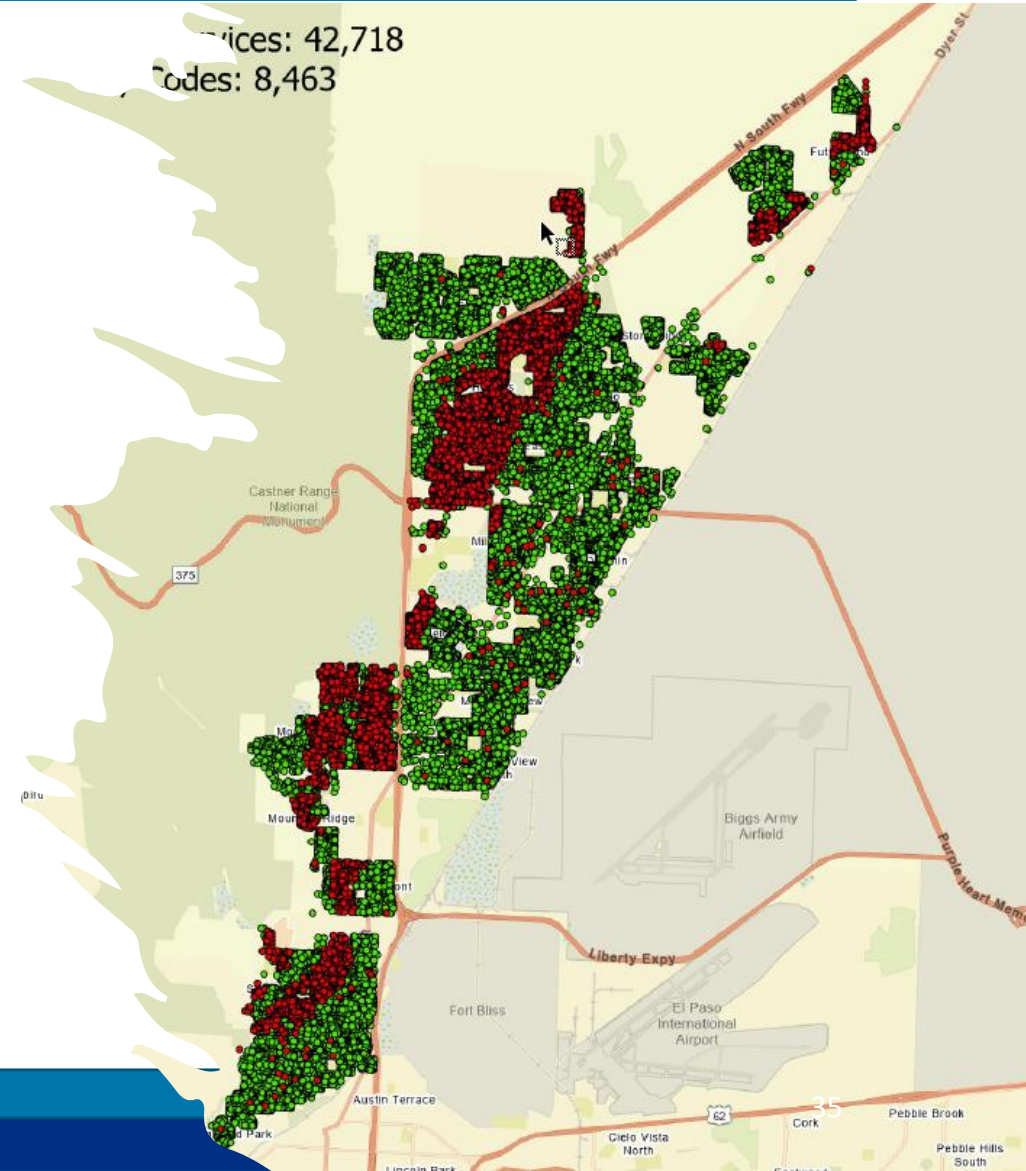
# Service Map for Sunday January 11<sup>th</sup>

- Green dots - customers with service.
- Red dots - meters reporting dry code.
- Looking for conglomeration of datapoints giving the same state

- *We reported 38,000 affected meters reported*

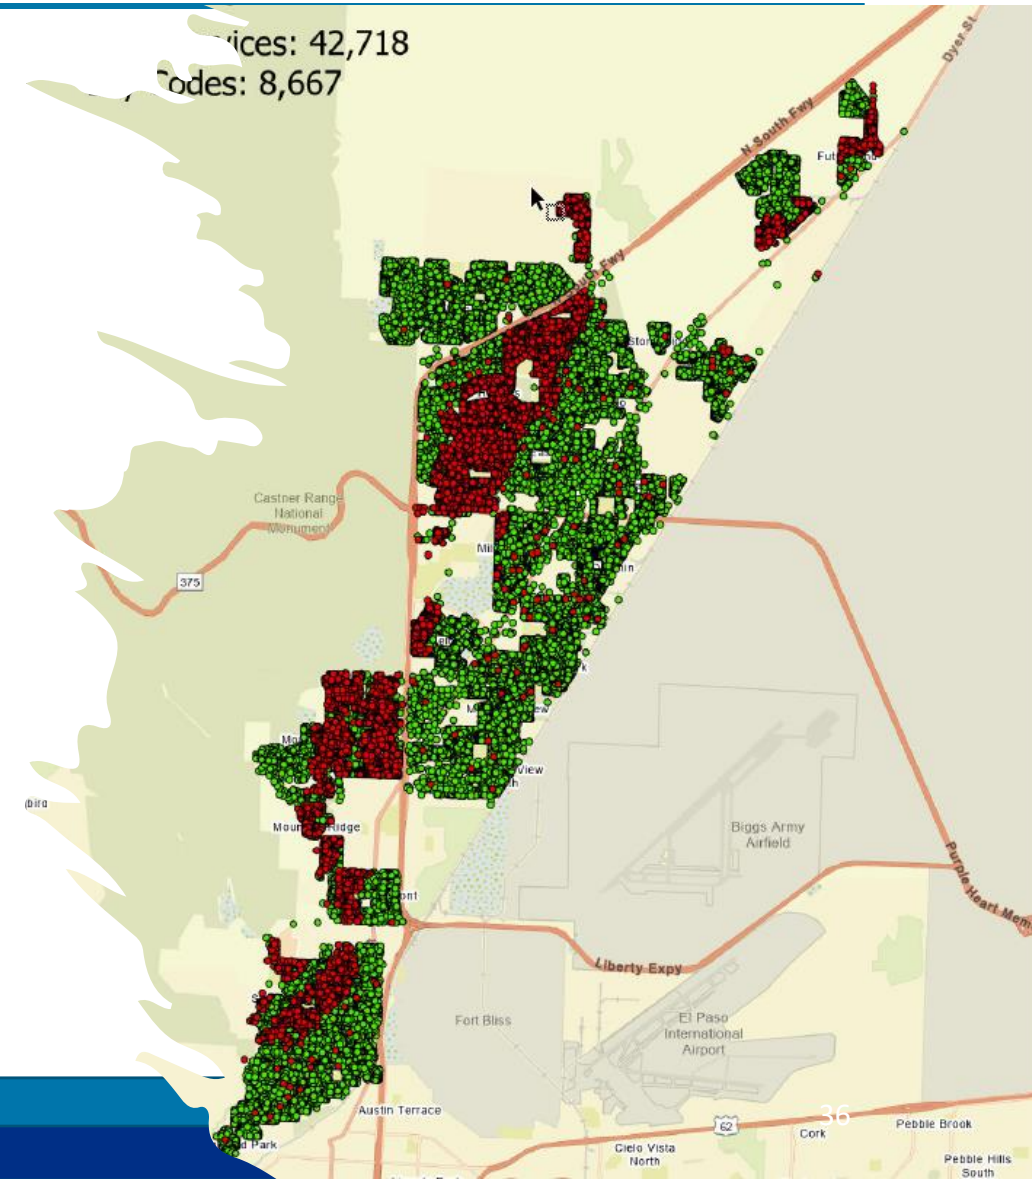
# Service Map for Monday January 12<sup>th</sup>

- Green dots - customers with service.
- Red dots - meters reporting dry code.
- Looking for conglomeration of datapoints giving the same state

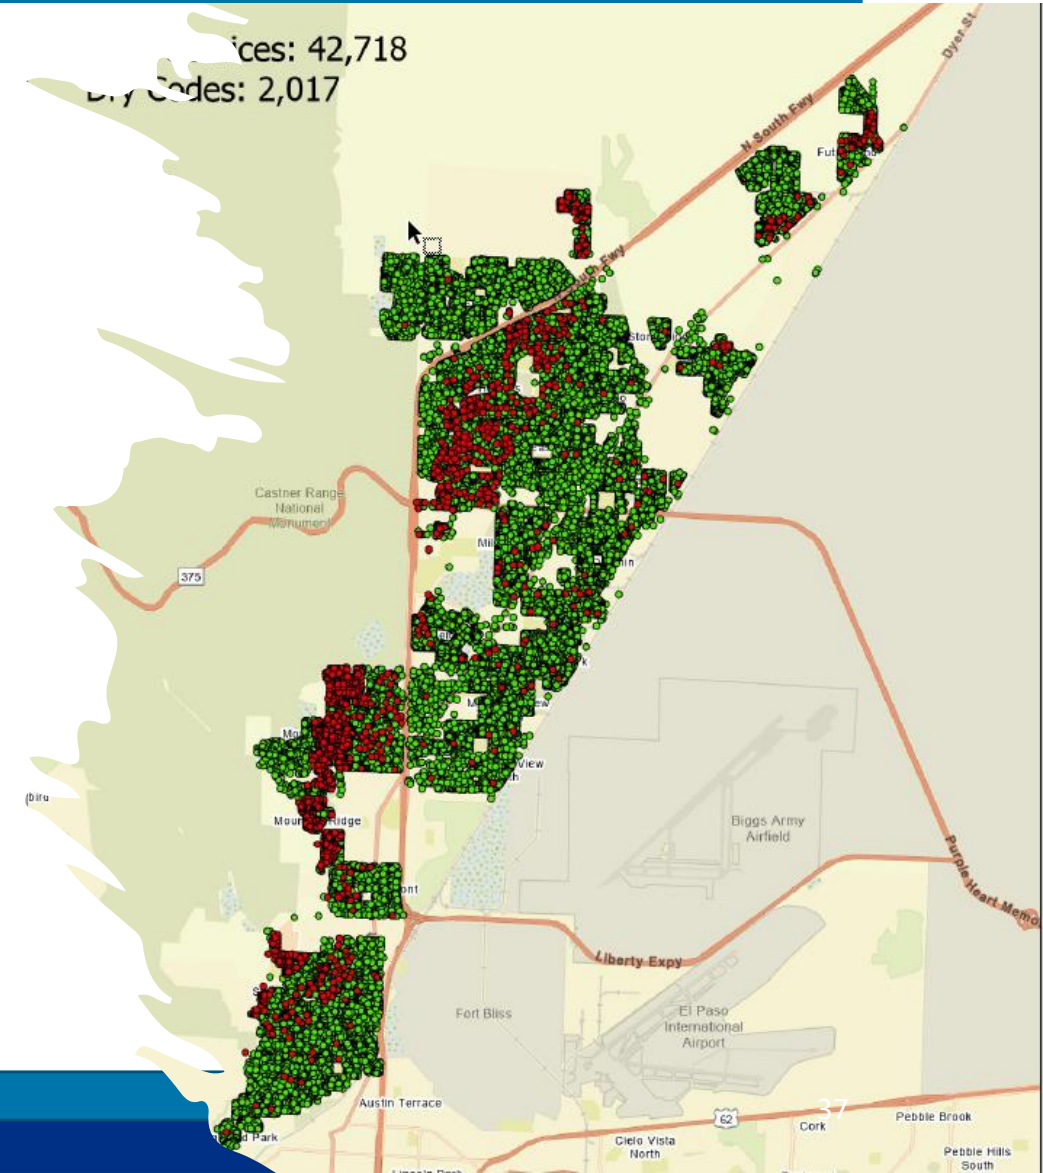
# Service Map for Tuesday January 13<sup>th</sup>

- Green dots - customers with service.
- Red dots - meters reporting dry code.
- Looking for conglomeration of datapoints giving the same state

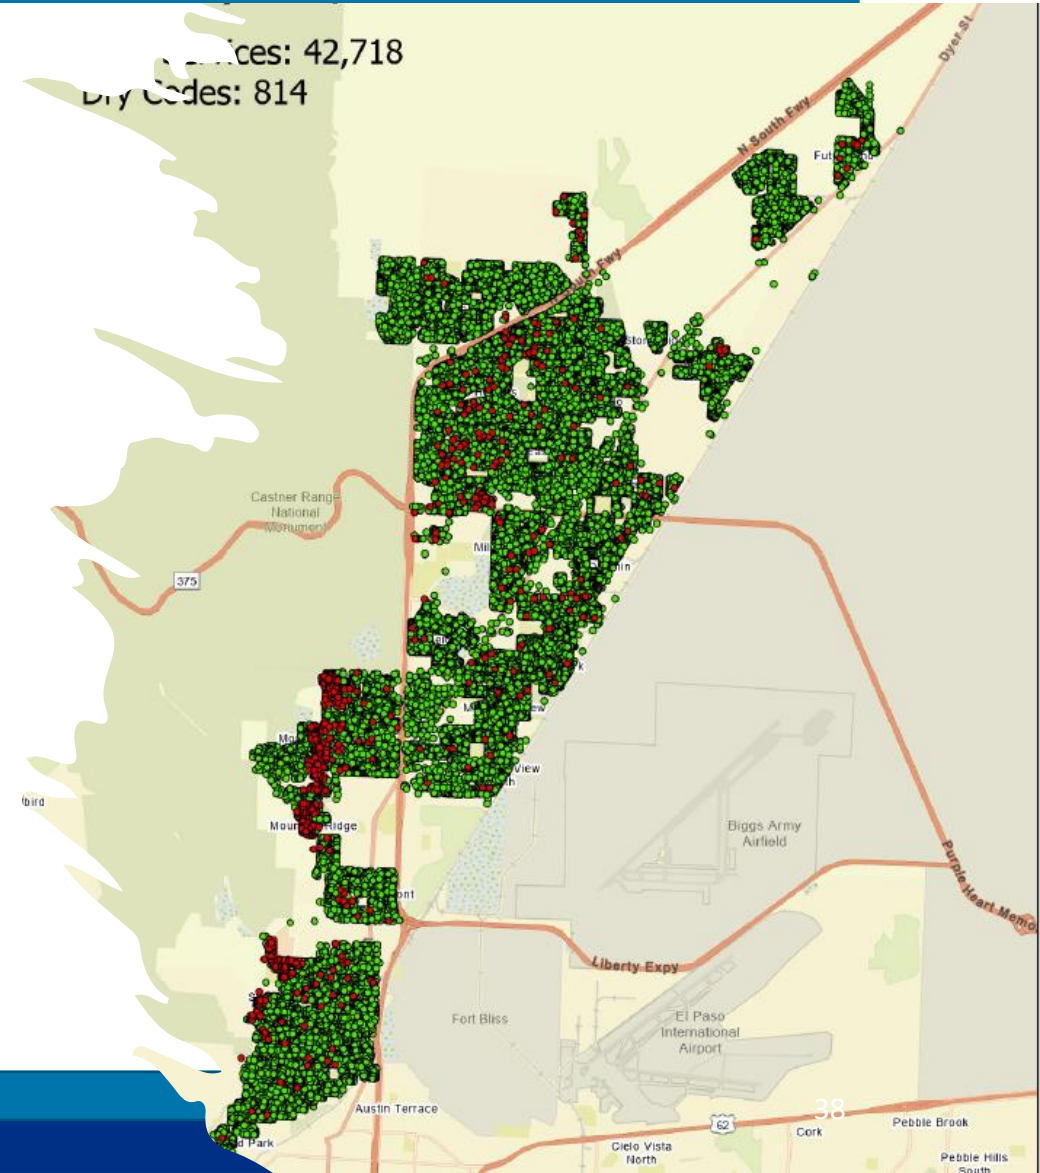
# Service Map for Wednesday January 14<sup>th</sup>

- Green dots - customers with service.
- Red dots - meters reporting dry code.
- Looking for conglomeration of datapoints giving the same state

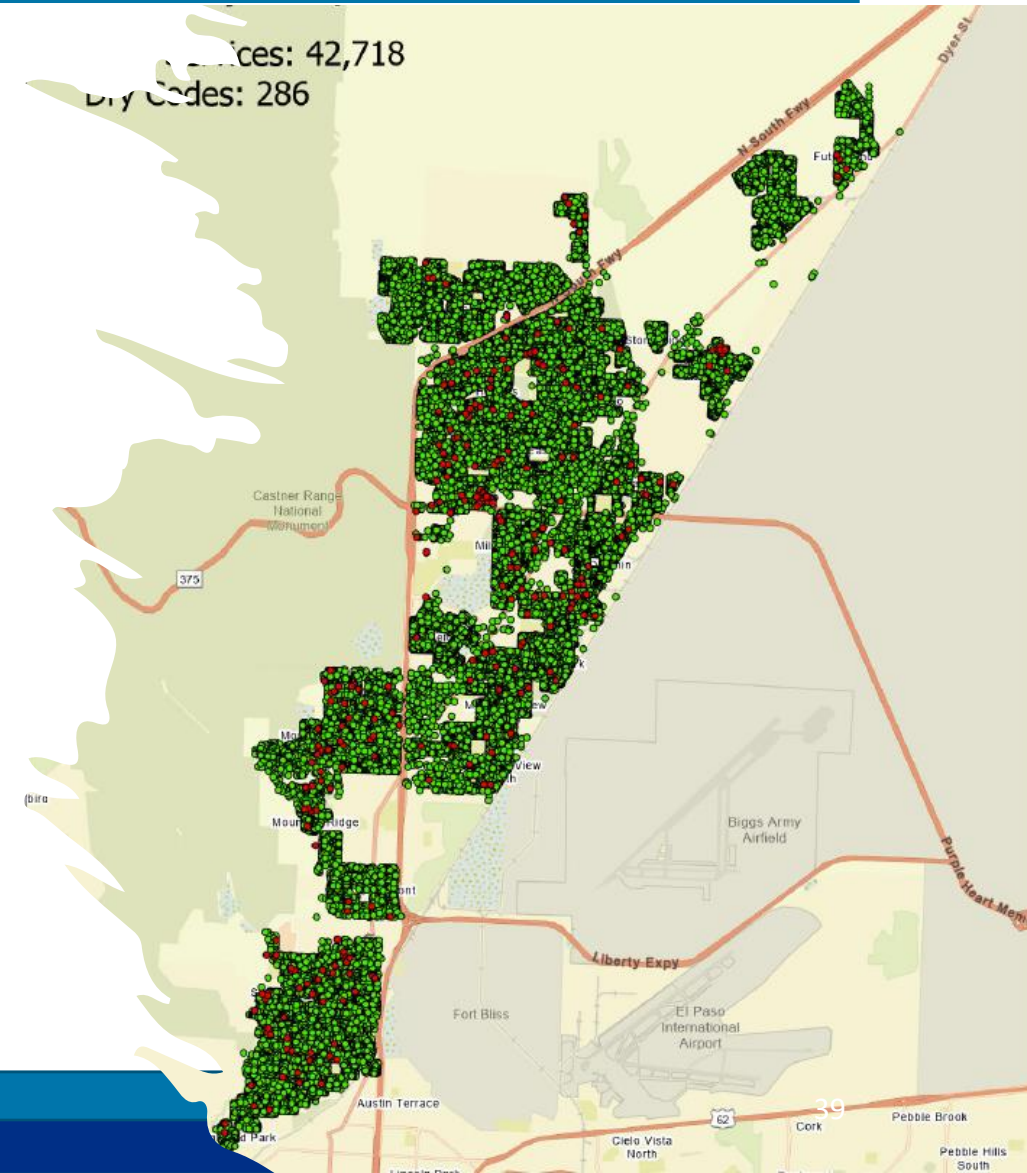
# Service Map for Thursday January 15<sup>th</sup>

- Green dots - customers with service.
- Red dots - meters reporting dry code.
- Looking for conglomeration of datapoints giving the same state

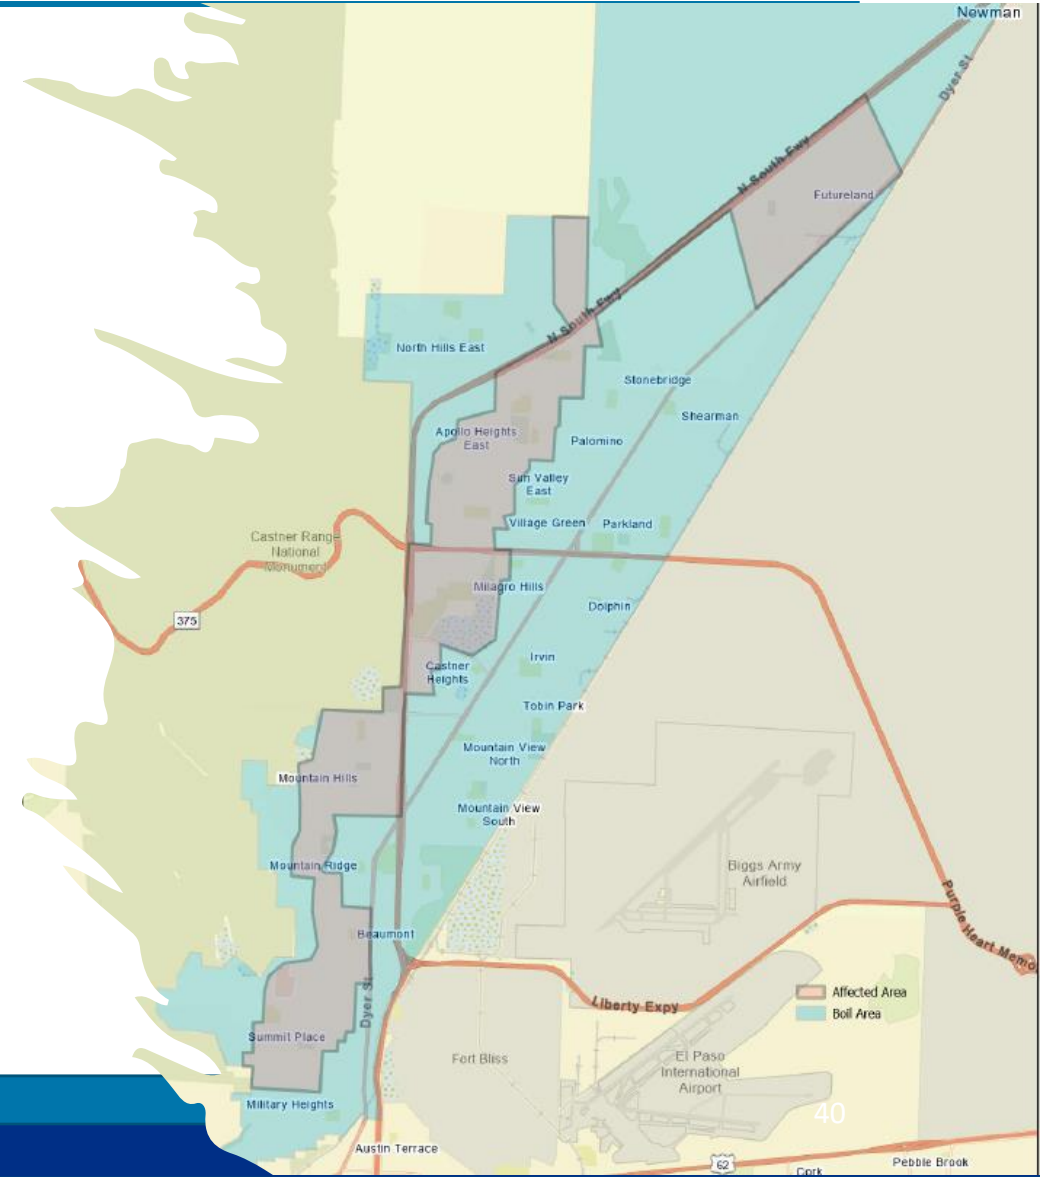
# Original Pressure Zone Map VS Affected Area

- Blue area - affected area originally presented
  - Estimated 38,000 customers
- Pink Area - actual affected area per Dry Codes
  - Updated Estimate 10,000 customers
