Transit Asset Management Plan

FY 2023 – 2026

September 2022

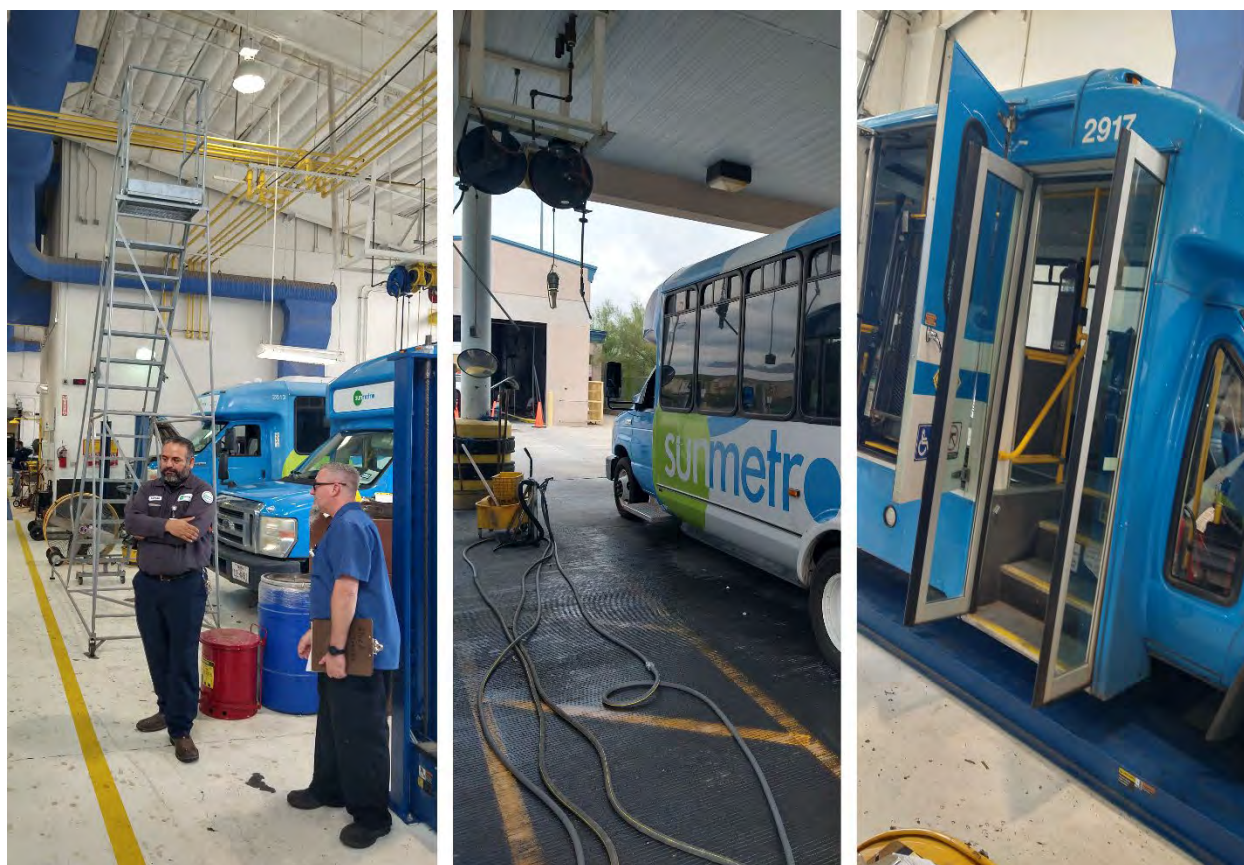
Figure 12 Sun Metro LIFT Facility Site Visit

The Sun Metro LIFT Facility was in good condition with clean interiors and exteriors. Most equipment was in good to excellent condition with exception of the parts washer, which was in marginal condition.

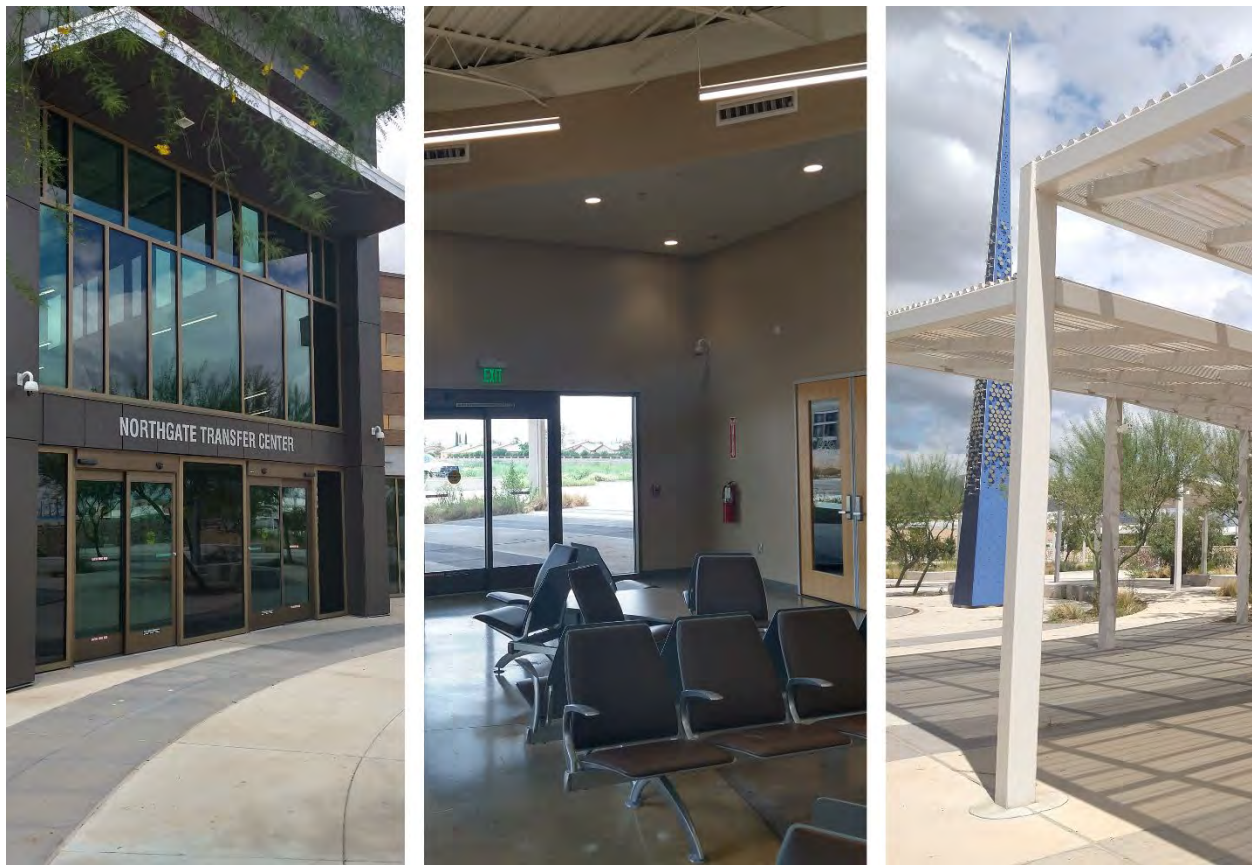
Figure 13 Arves E. Jones, Sr. Transit Center at Northgate Site Visit

The Arves E. Jones, Sr. Transit Center at Northgate was in excellent condition with clean interiors and exteriors. There is vacant shell space that is currently not being utilized.

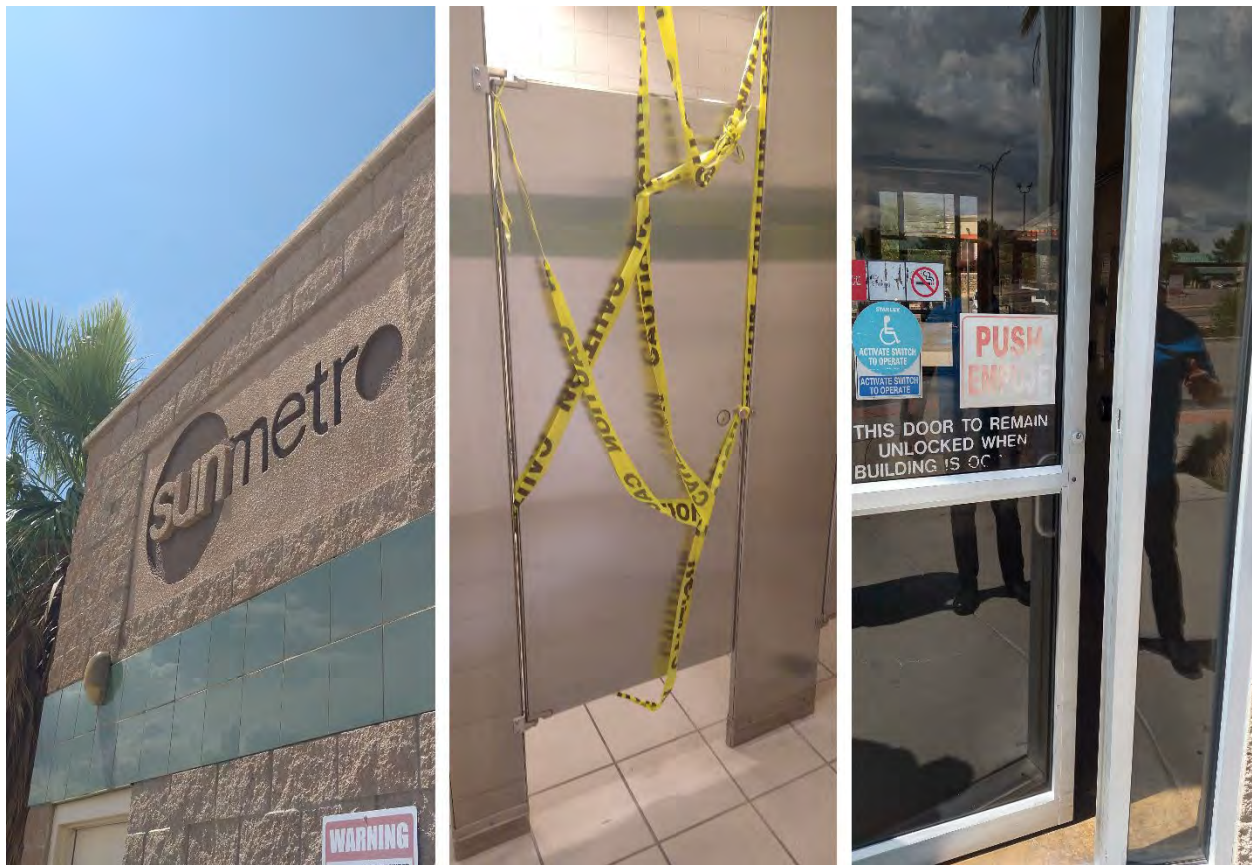
Figure 14 Al Jefferson Westside Transfer Center Site Visit

The Al Jefferson Westside Transfer Center was in good condition with issues in the middle building with plumbing and door closure. The waiting areas were in need of fire extinguishers.

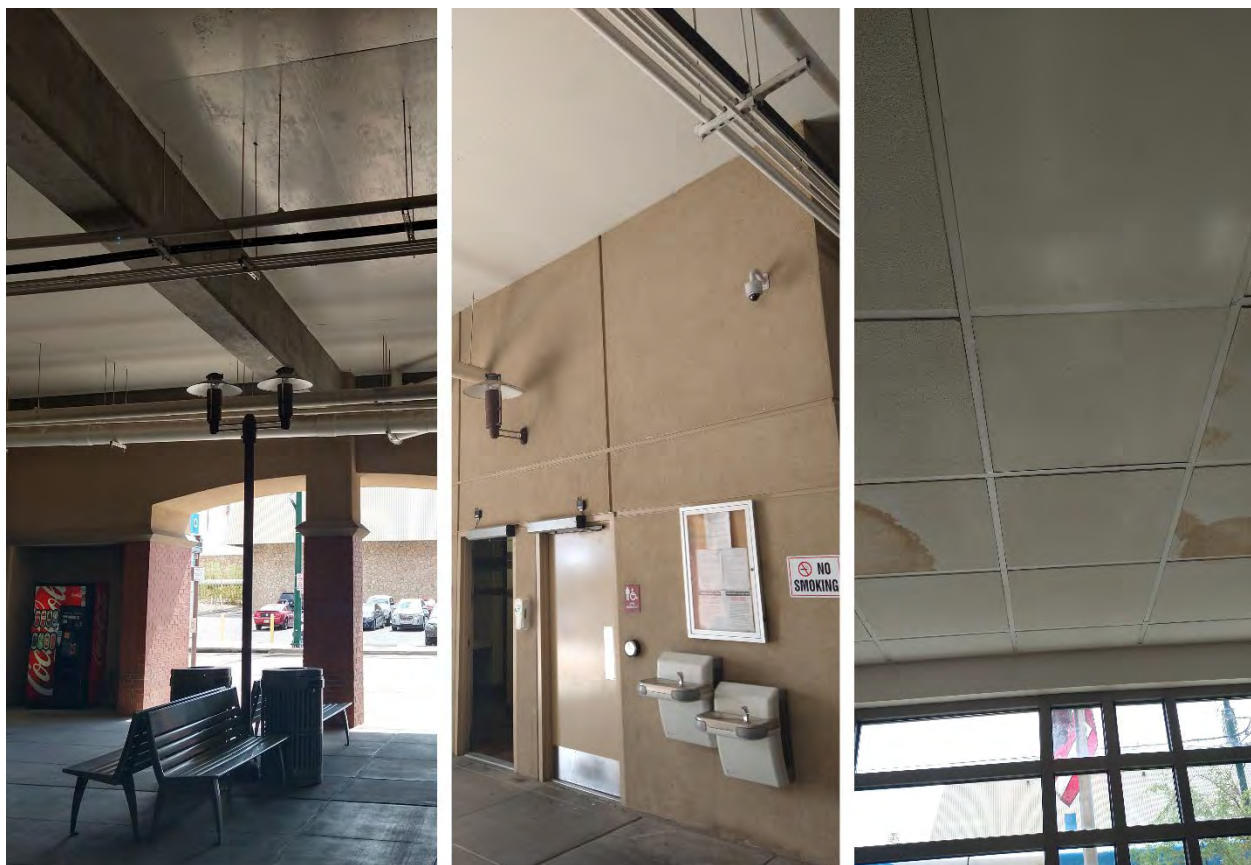
Figure 15 Glory Road Transfer Center Site Visit

The Glory Road Transfer Center was in good condition with damage from a leak from the HVAC in the waiting area that has been repaired.

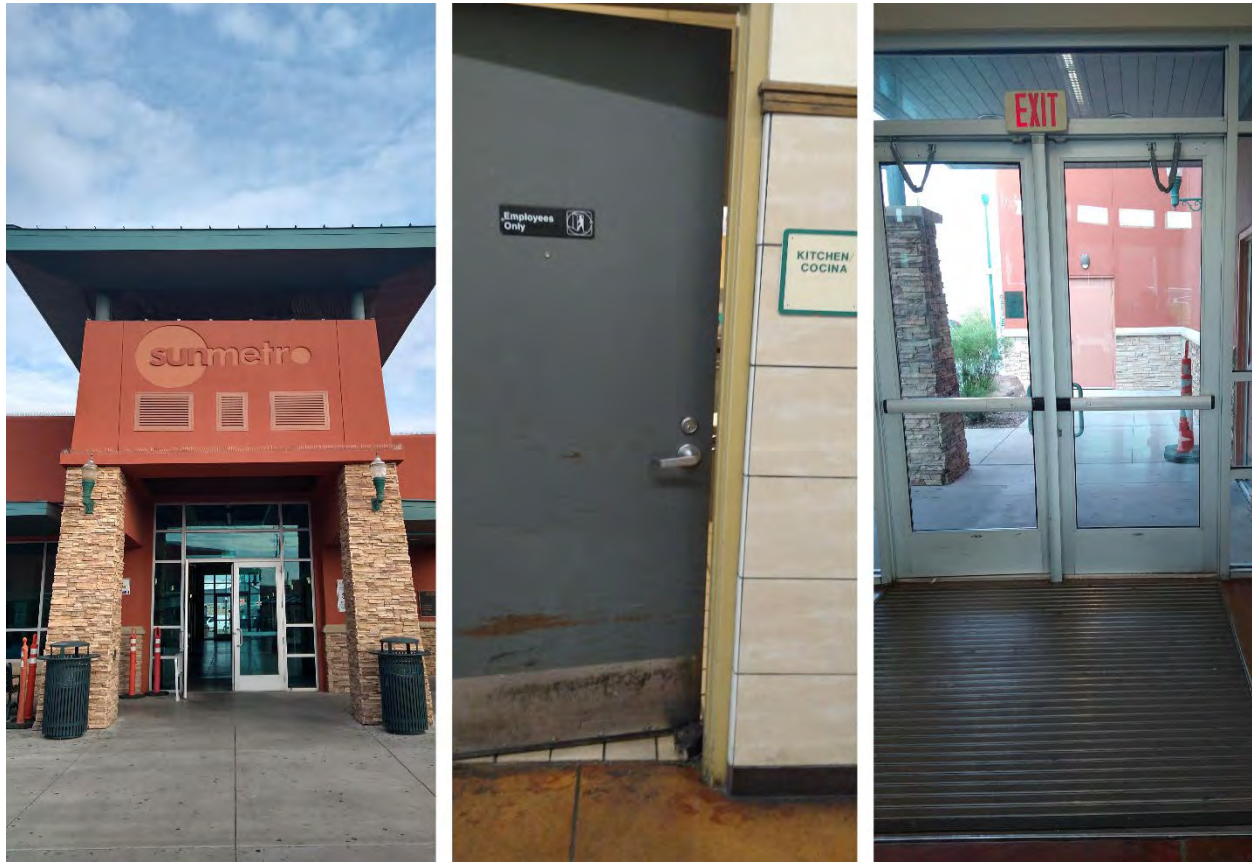
Figure 16 Bert Williams Downtown Santa Fe Transit Center Site Visit

The Bert Williams Downtown Santa Fe Transit Center was in adequate condition with some issues apparent in the floor and had a good amount of wear from heavy use.

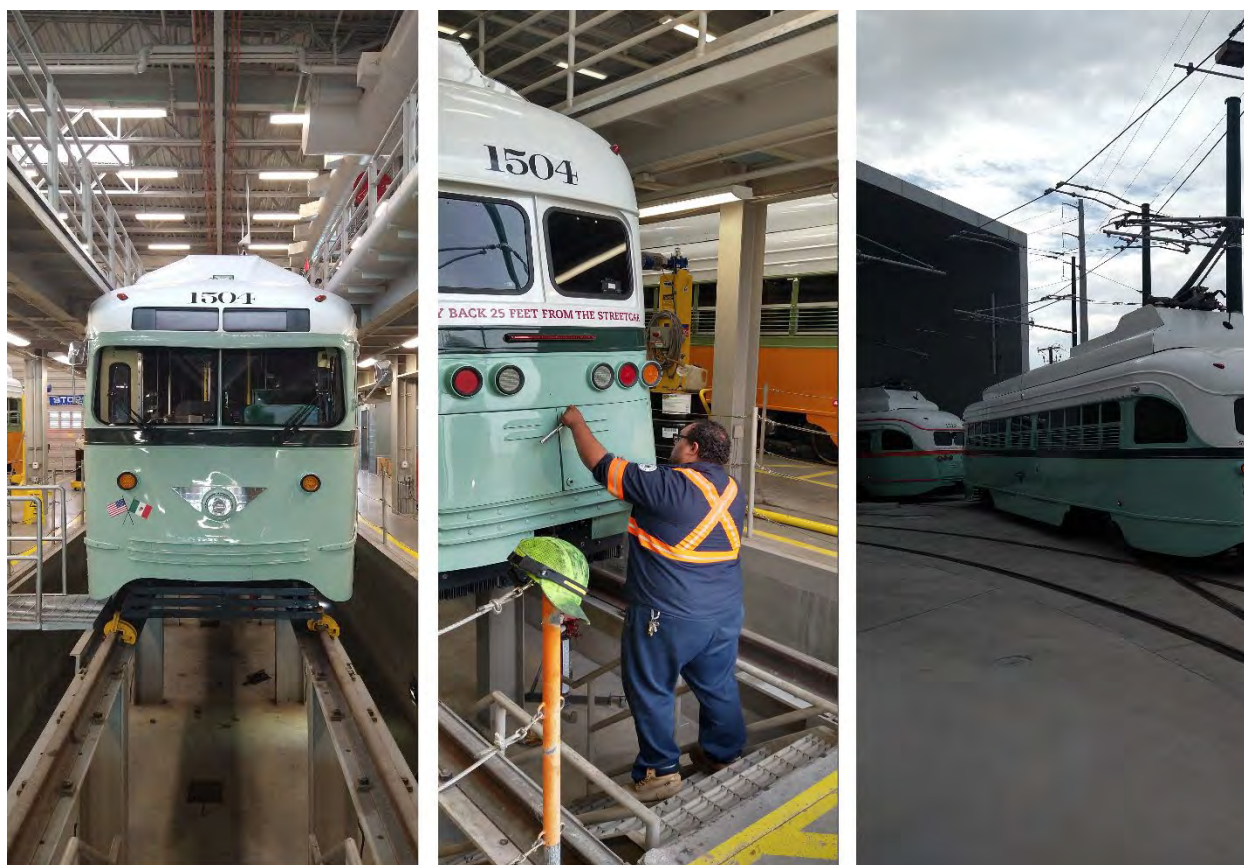
Figure 17 Maintenance Services Facility Site Visit

The Maintenance Services Facility is in excellent condition with a clean facility and well-maintained equipment.

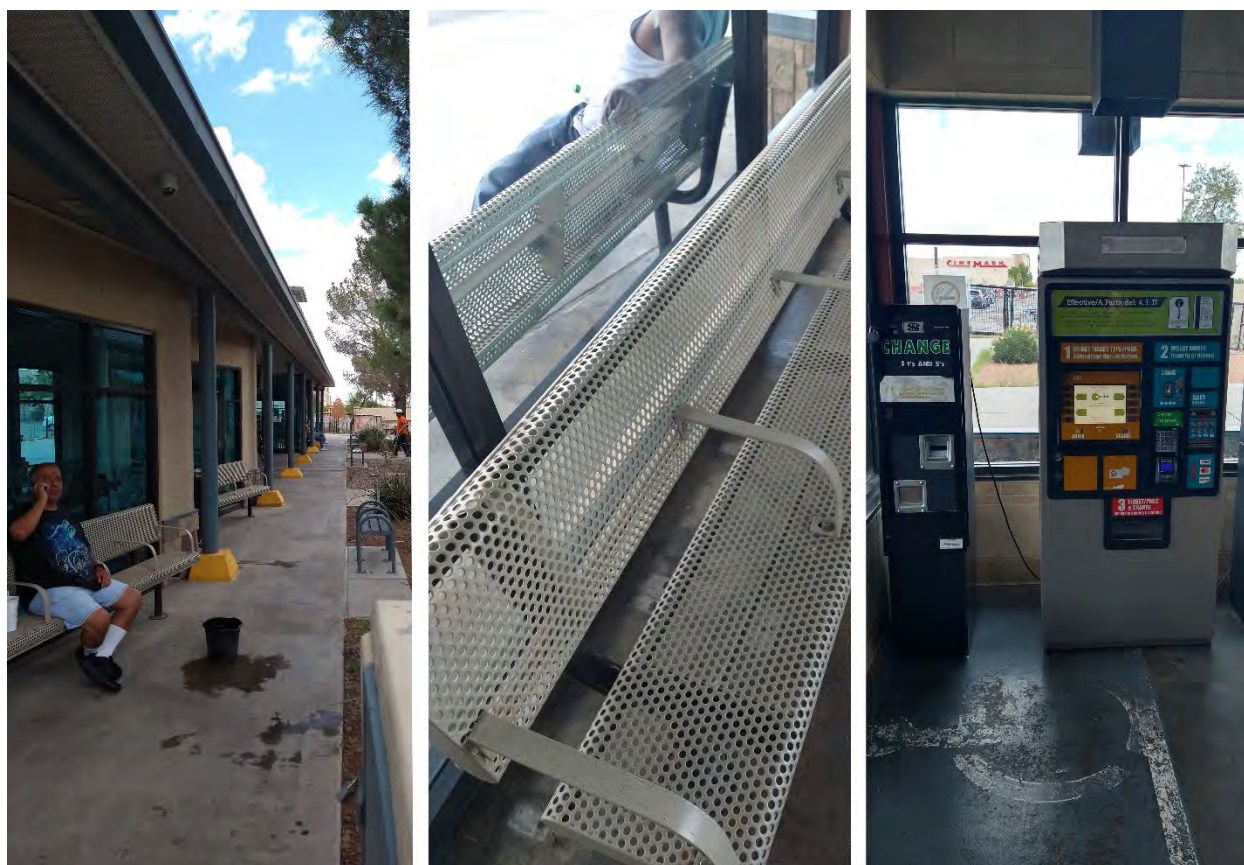
Figure 18 Arturo Tury Benavides Cielo Vista Transit Center Site Visit

The Arturo Tury Benavides Cielo Vista Transit Center was in adequate condition with some issues with the gutters, HVAC, and lack of fire extinguishers or fire suppression systems.

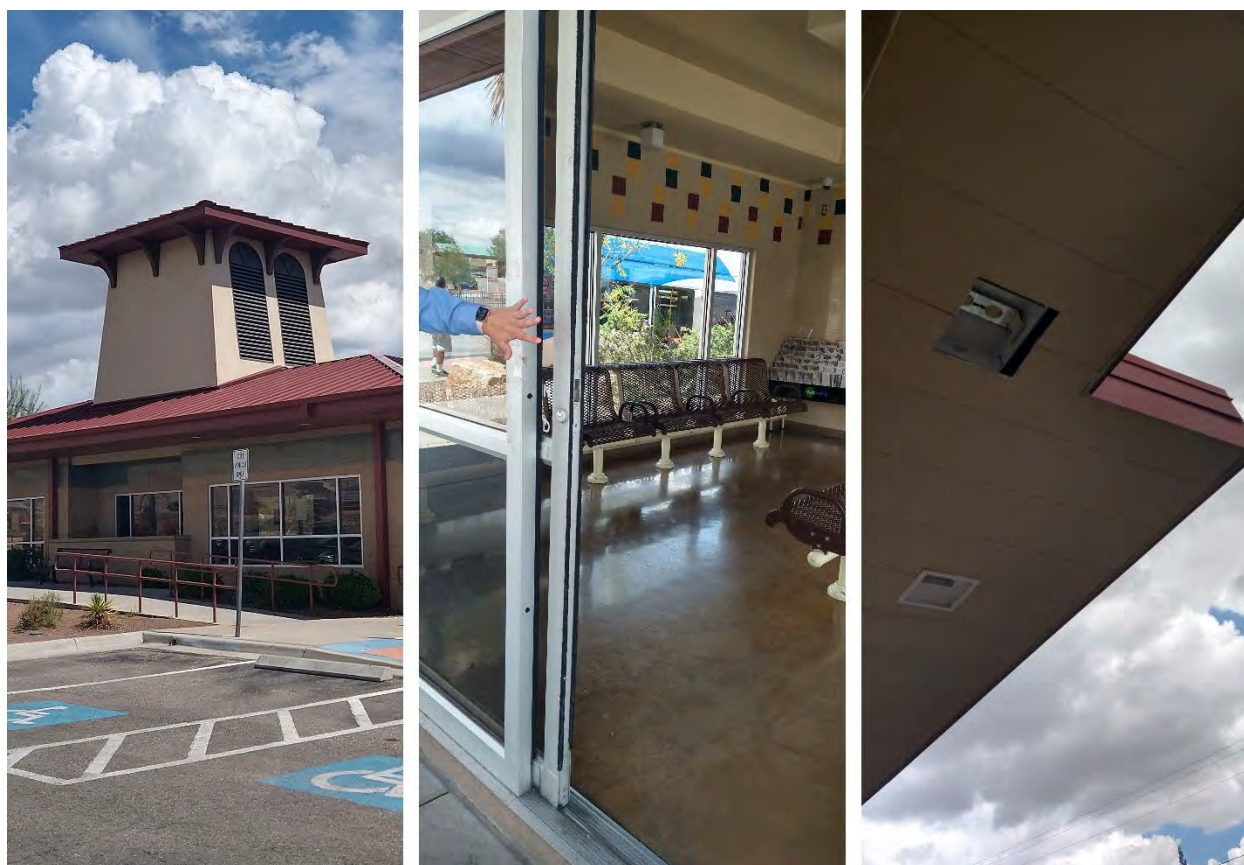
Figure 19 Robert E. McKee Five Points Transit Center Site Visit

The Robert E. McKee Five Points Transit Center was in good condition with some issues in one of the waiting areas with the HVAC and leaking through the outdoor light fixture.

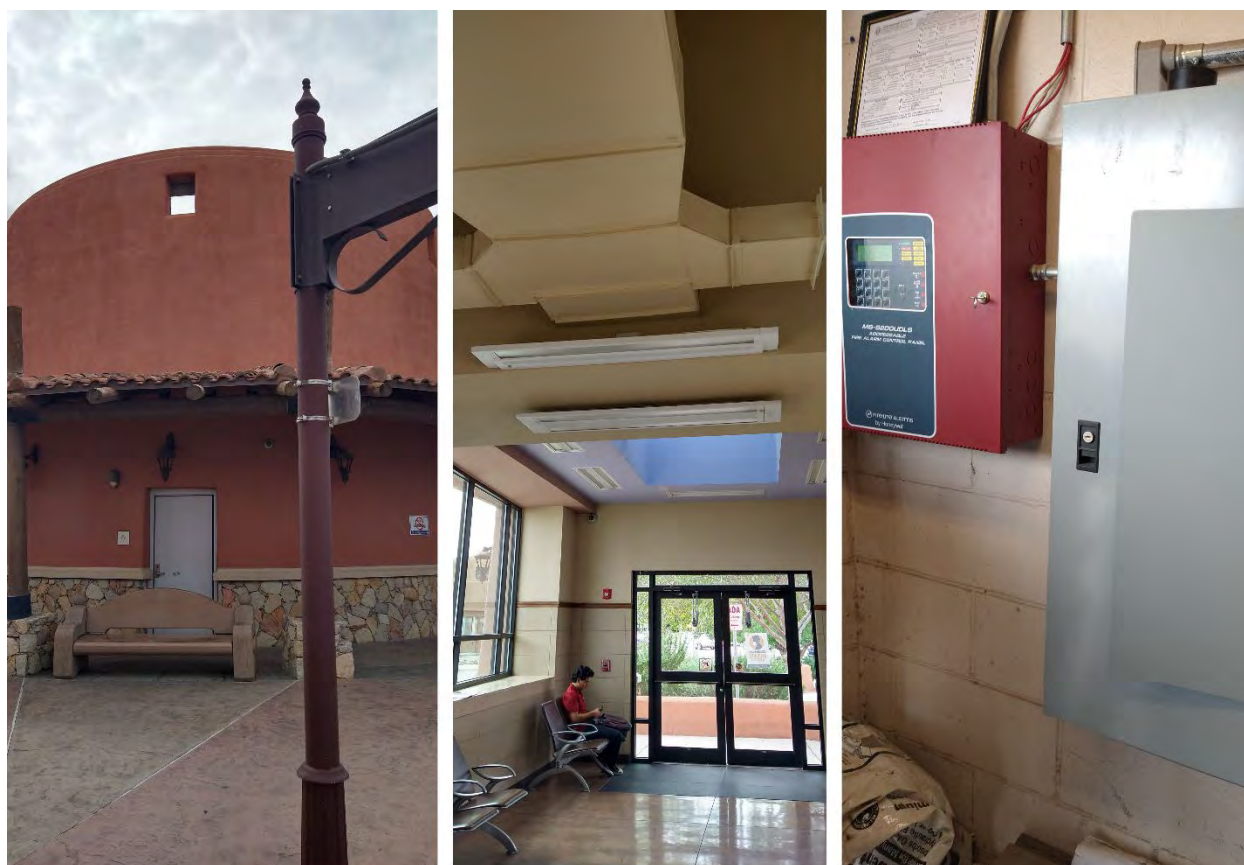
Figure 20 Nestor A. Valencia Mission Valley Transit Center Site Visit

The Nestor A. Valencia Mission Valley Transit Center was in good condition with some issues with the HVAC.

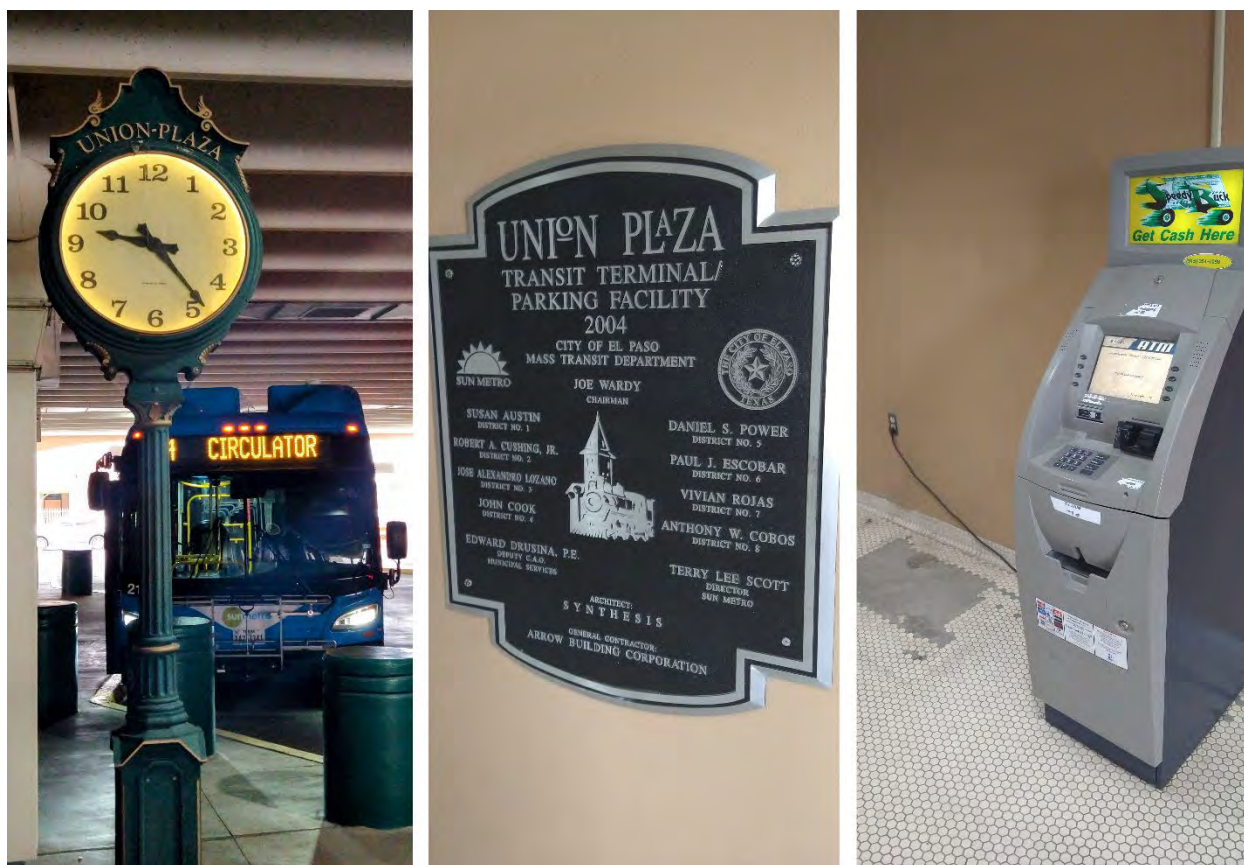
Figure 21 Union Plaza Transit Terminal Parking Garage Site Visit

The Union Plaza Transit Terminal Parking Garage was in adequate condition with wear on the facility and TVM removed from the interior.

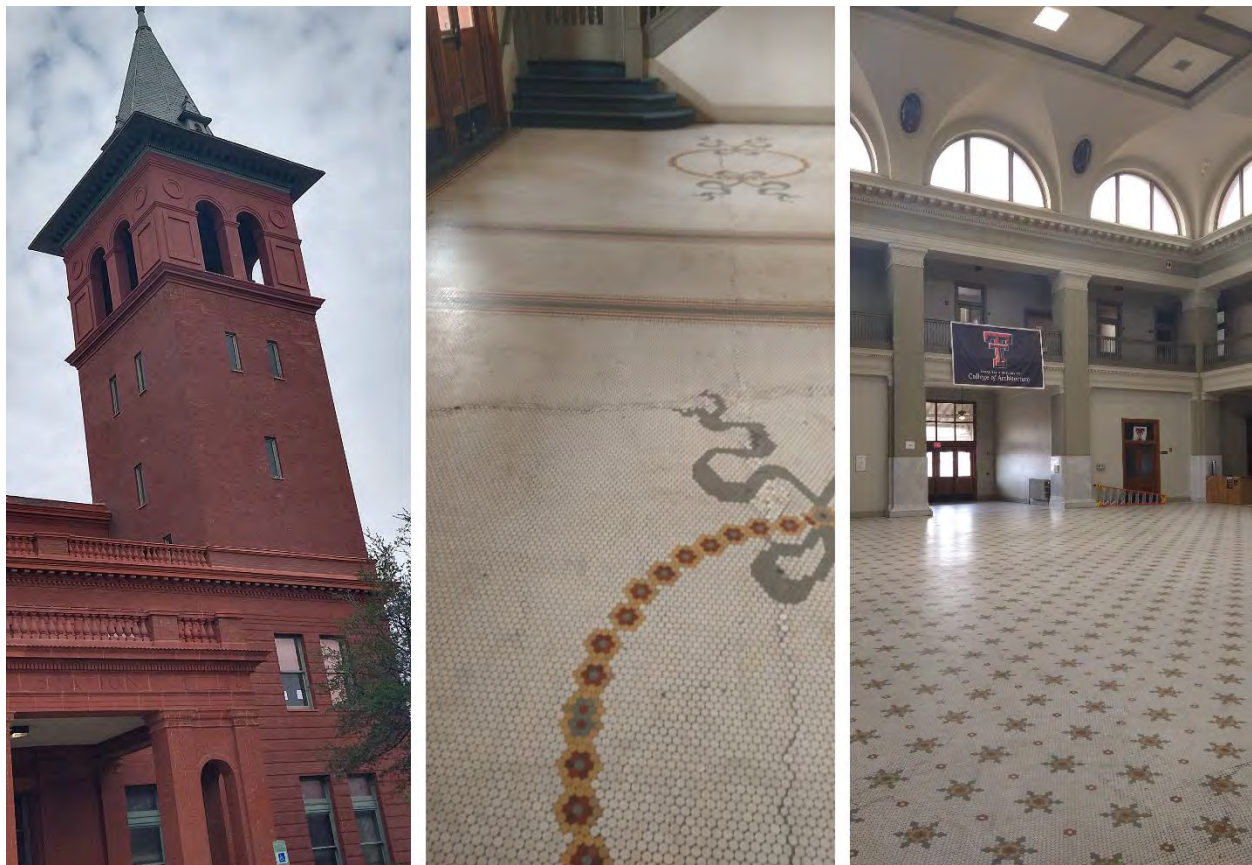
Figure 22 Union Depot Site Visit

The Union Depot is in marginal condition with visible issues to floor and roof of the facility. The building is in need of improvements while no Sun Metro operations are held in the building. Texas Tech University, Amtrak, and Greyhound lease offices in the building.

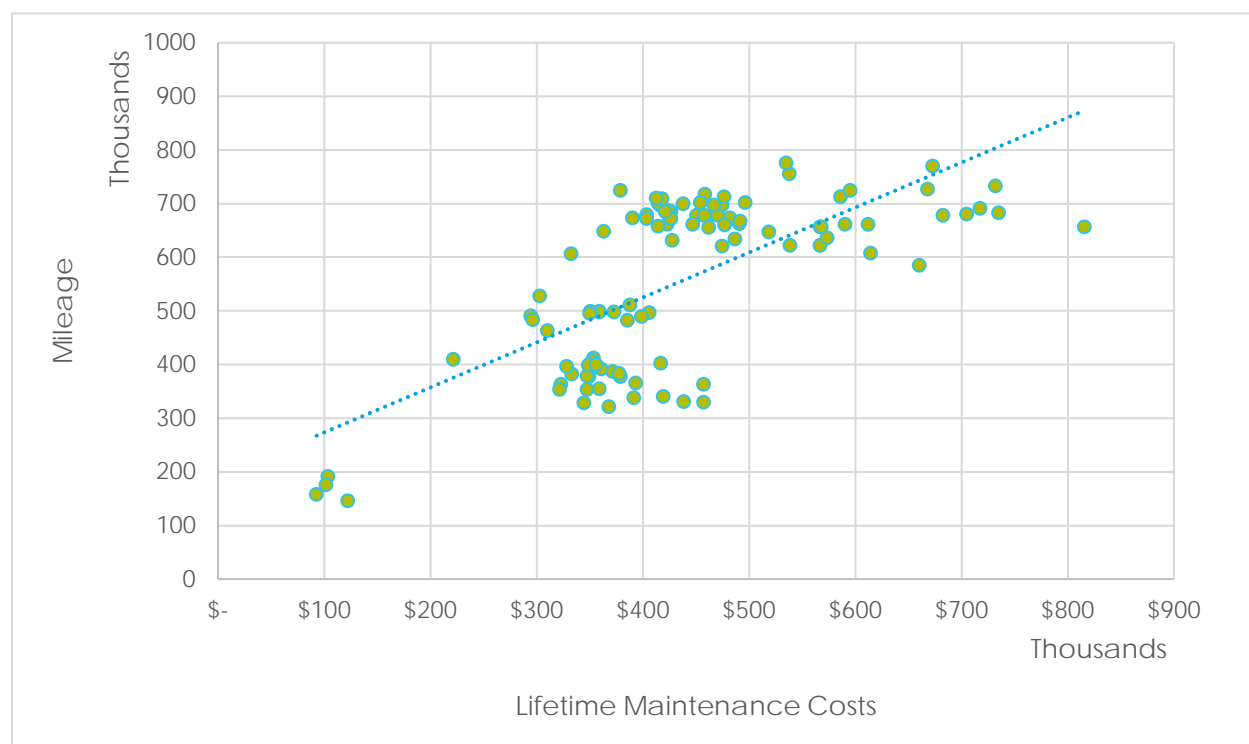
For the 35 40-foot fixed route rolling stock, 120 vehicles are over 500,000 miles. Of those vehicles, maintenance costs range from \$300,000 to \$815,000 over the vehicles' lifecycles with the highest maintenance costs are for the 2004 buses.

Figure 25 Lifetime Maintenance Cost against Mileage
