Frontera Force Main Update

Frontera Force Mains: Essential Wastewater Artery

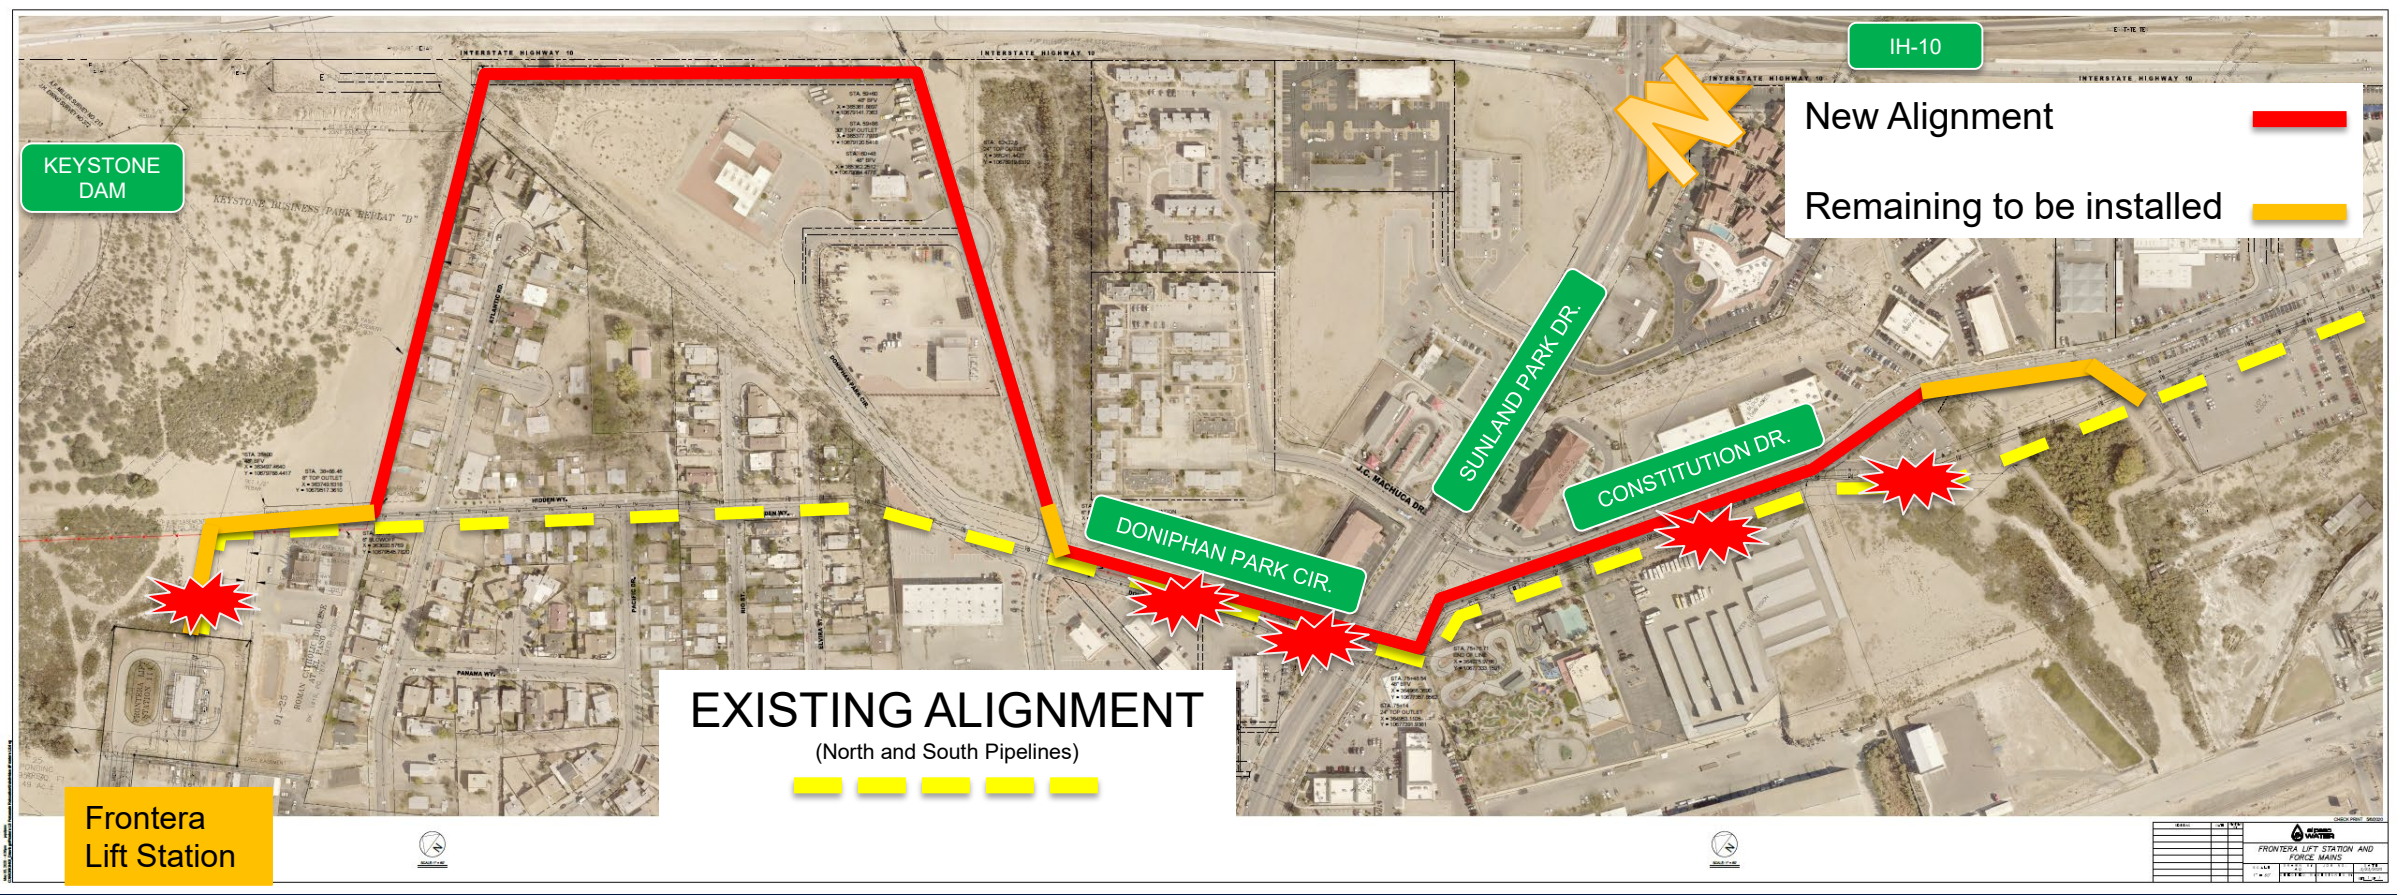
Emergency Repairs to Frontera Force Mains

Replace 1.2 miles of 36" Force Main

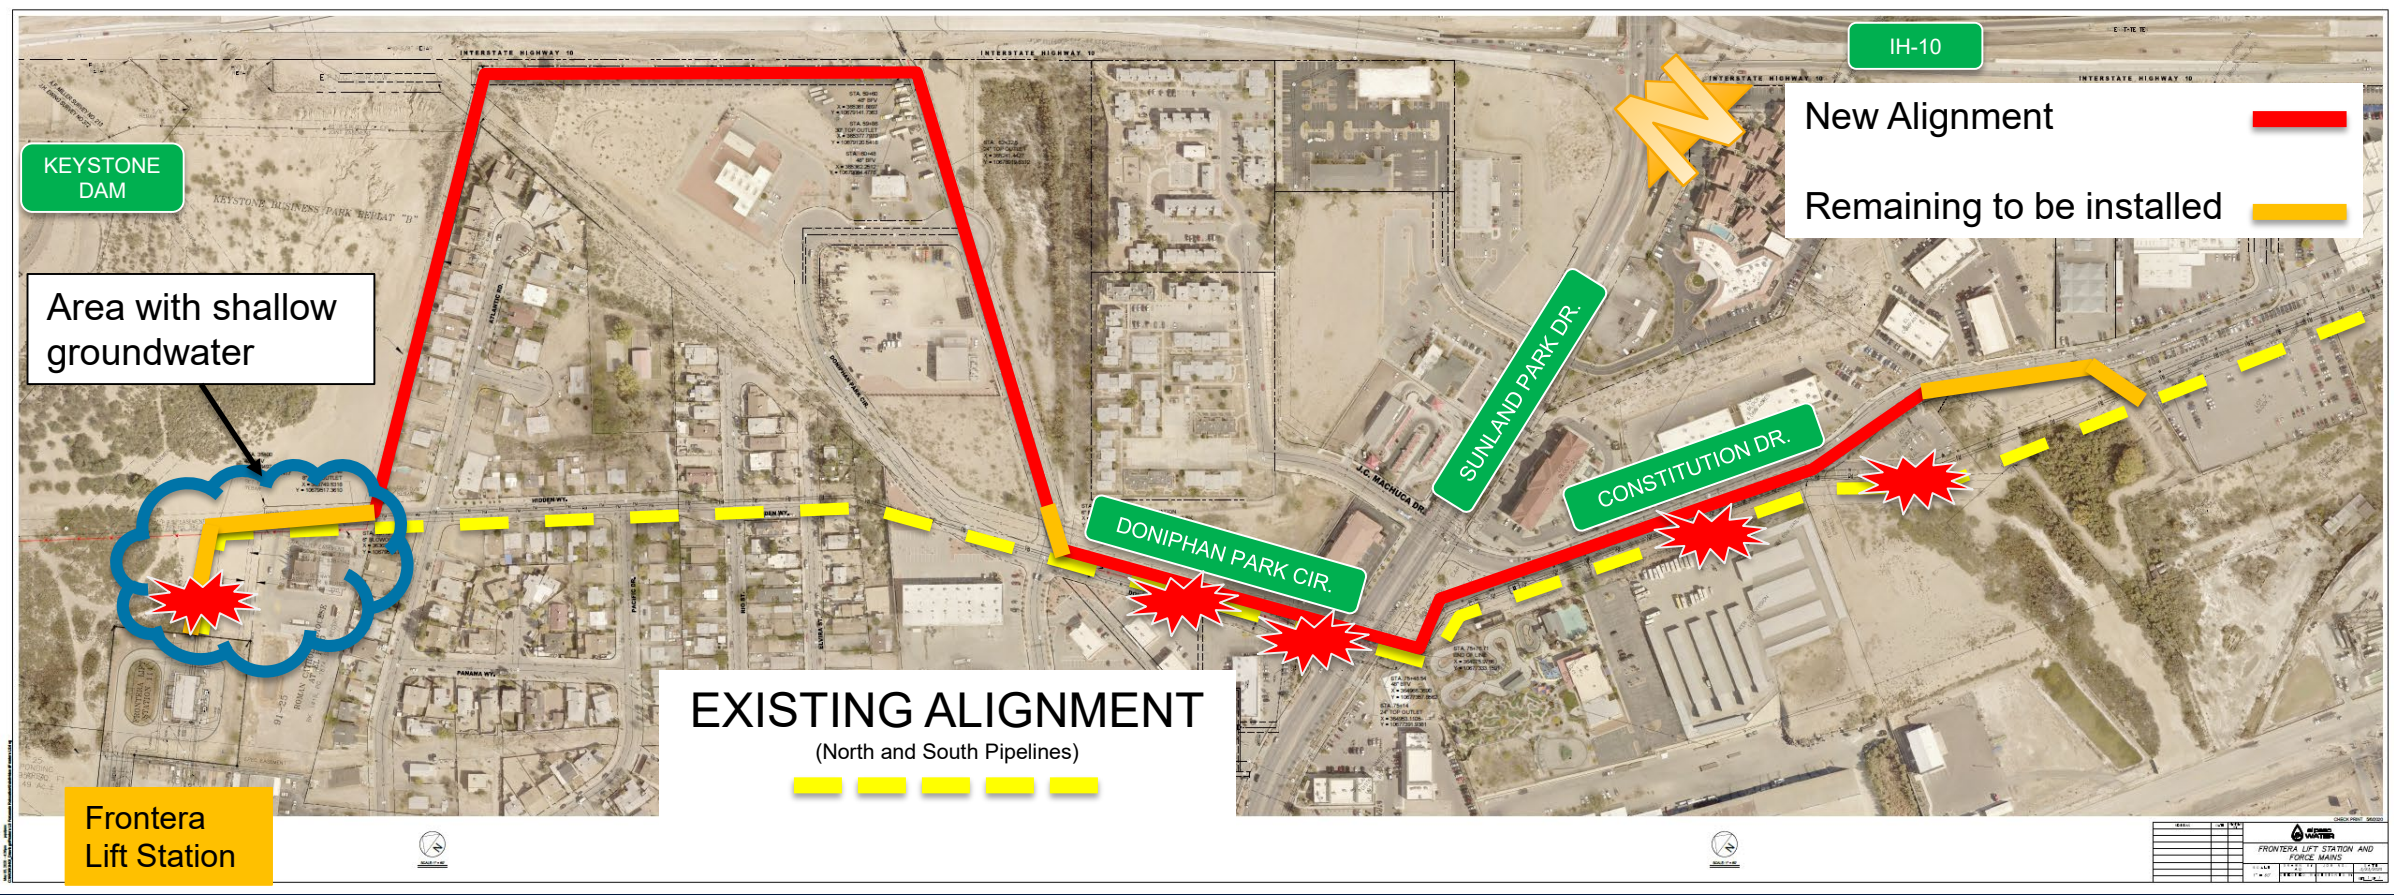
Emergency Repairs to Frontera Force Mains

Replace 1.2 miles of 36" Force Main

South Pipe - REPAIRED	North Pipe - REPAIRED
Doniphan Park Circle	Best Western
South Pipe – NOT REPAIRED	North Pipe – NOT REPAIRED
Constitution Parking Lot <i>Discharge to stormwater system/river</i>	Doniphan Park Circle <i>Discharge to adjacent pond</i>
	Constitution Parking Lot <i>Discharge to stormwater system/river</i>
	Constitution Storage Facility <i>Discharge to stormwater system/river</i>
	Frontera Lift Station <i>Discharge to Keystone Dam Outfall/river</i>

Continue repair of the south pipe; regain pipeline operation

- Repair south pipe at constitution parking lot to shift flow to the south pipe
- Abandon north line in place, too many breaks, highly unreliable
- Stop all discharges in the right-of-way
