# Quarterly Presentation: Final Report on Northeast Main Break Incident

June 23, 2026

# Northeast Main Break Incident Overview

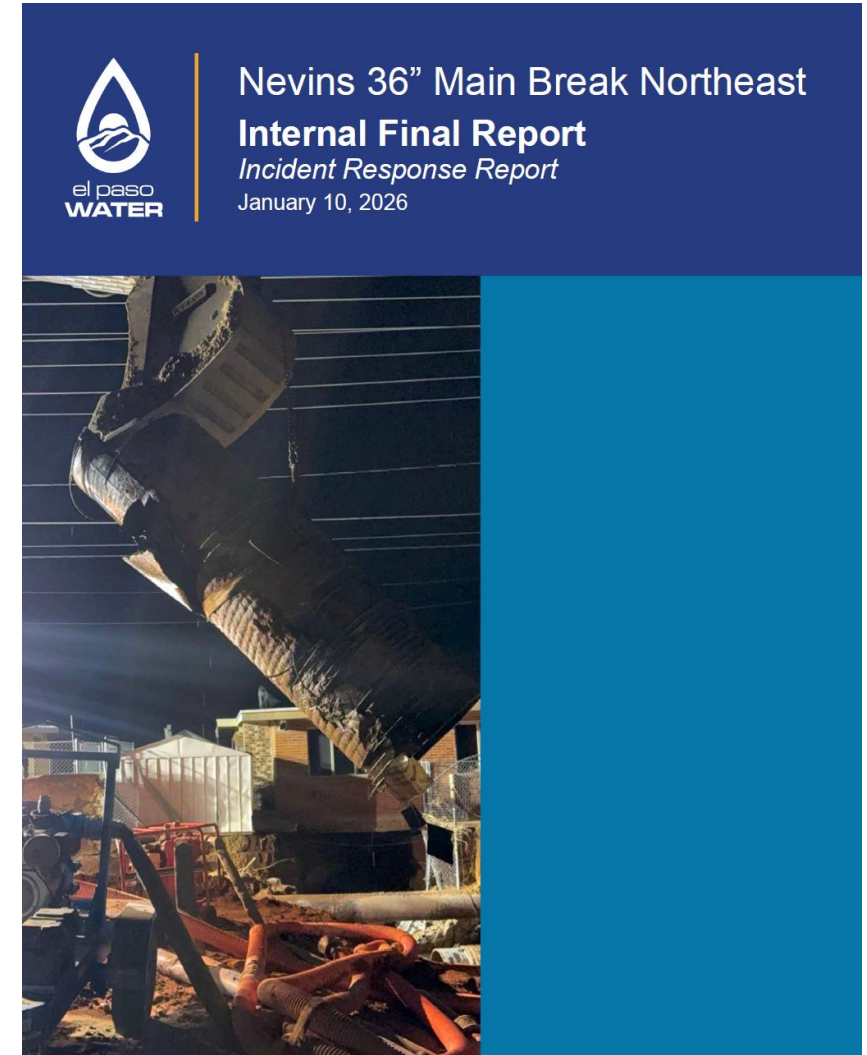
- A 36-inch transmission line broke in the late night of Jan. 10
- The break depleted nearby storage tanks, resulting in low pressure or loss of service to approximately 38,000 service connections
- A precautionary Boil Water Notice was issued in coordination with TCEQ
- The response required valve isolation and continuous dewatering to allow for repairs
- The system was fully restored by Jan. 15

The 36-inch transmission main was constructed of pre-stressed steel cylinder concrete pipe

The break was determined to be caused by corrosion and an electrical surge-induced pressure spike in the system.

- The pressure spike caused the corroded segment of pipe to break
